Englewood Home Inspections

Confidential - Property Inspection Report - Confidential

Any Location, USA, FL 12345
Inspection prepared for: Mr. Sample
Date of Inspection: 1/1/2010 Time: 9:00
Age of Home: 30 Years Size: 2500 Square feet

Inspector: Rob Kaleda
FL License HI8309
PO Box 790, Placida, FL 33946
Phone: 941-473-1574
Email: ehi2000@live.com

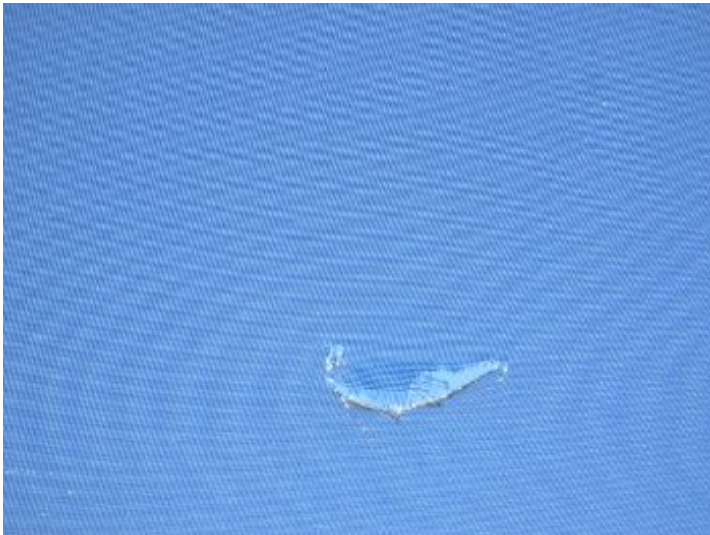
Torn/damaged screens.

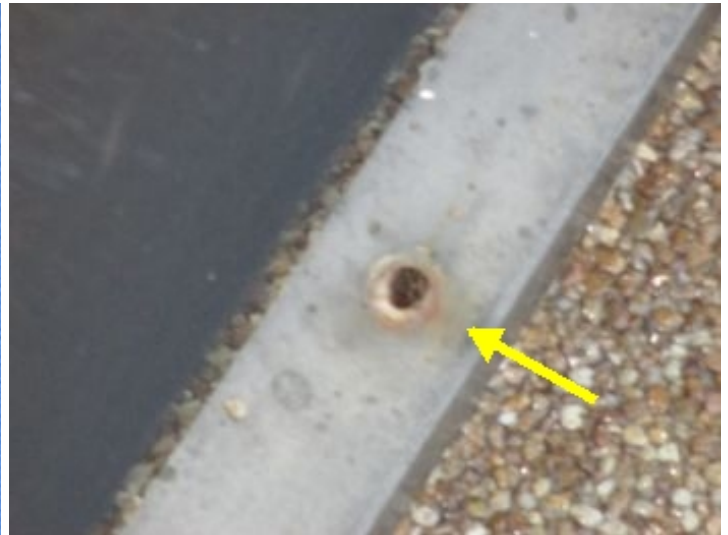
Fasteners of the screen frame to the concrete were deteriorated and should be resecured / replaced as needed.

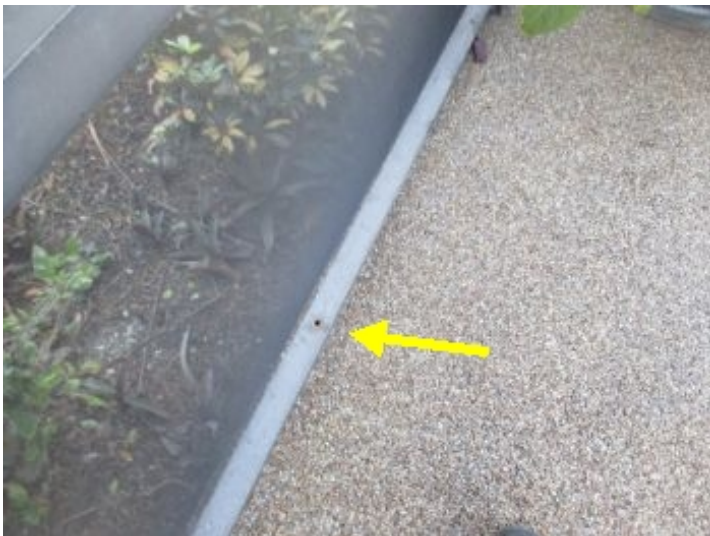
Fasteners of the screen frame to the concrete were deteriorated and should be resecured / replaced as needed.

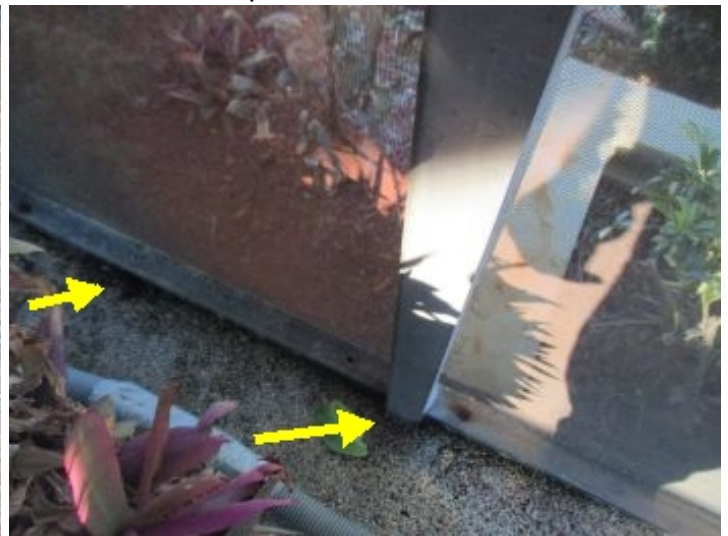
Fasteners of the screen frame to the concrete were deteriorated and should be resecured / replaced as needed.

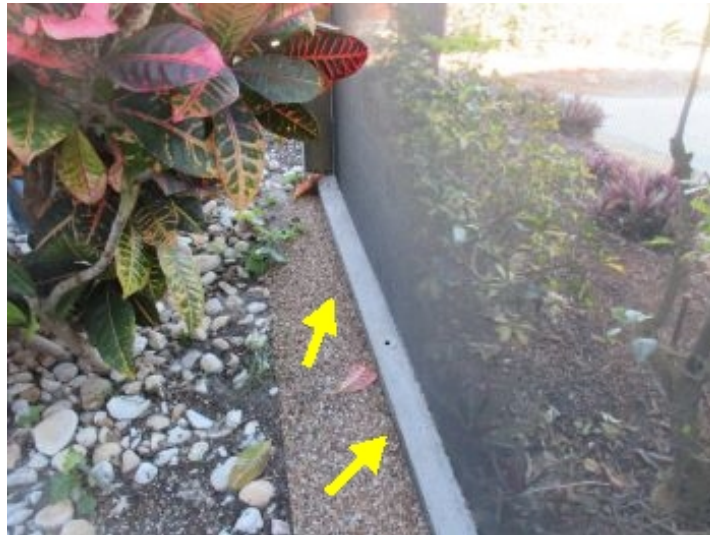
Fasteners of the screen frame to the concrete were deteriorated and should be resecured / replaced as needed.

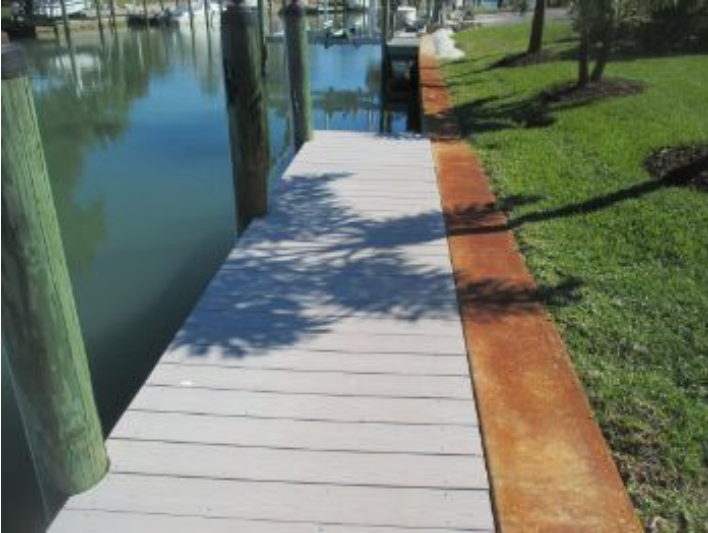
Appears in satisfactory and functional condition with normal wear for its age.

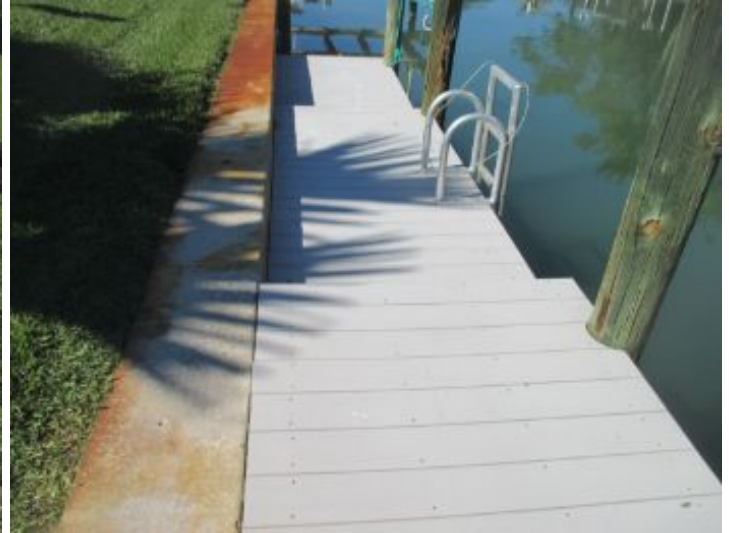
Appears in satisfactory and functional condition with normal wear for its age.

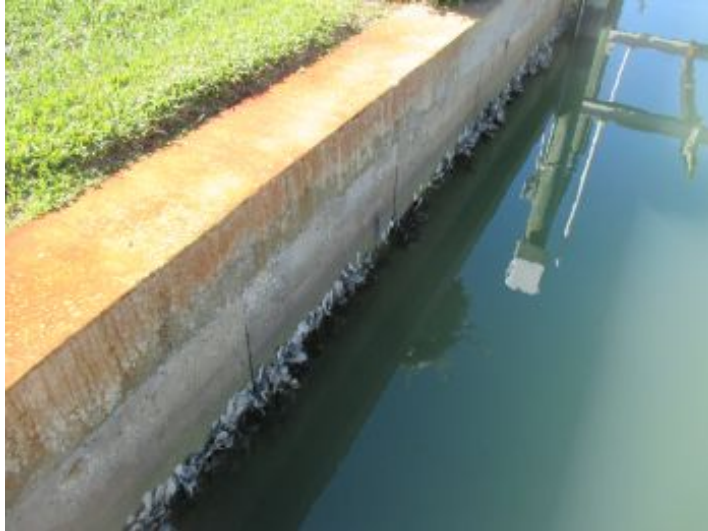
General overall condition appear satisfactory at the time of inspection.

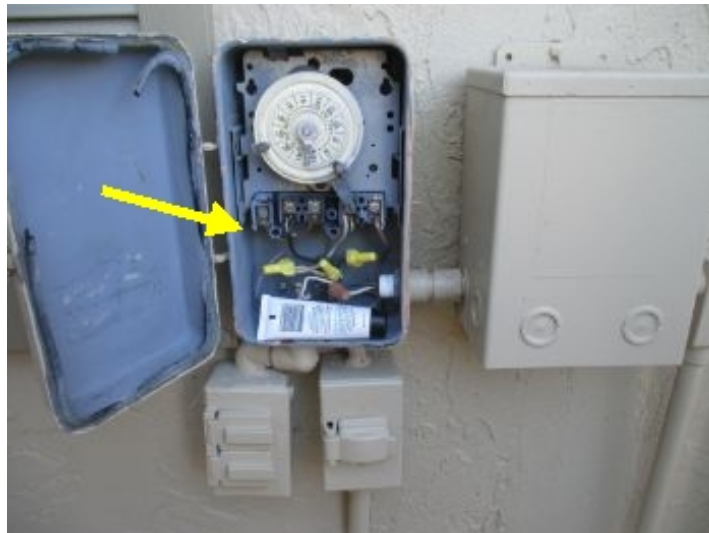
Terminal cover missing. Recommend installing cover to prevent accidental contact with energized terminals.

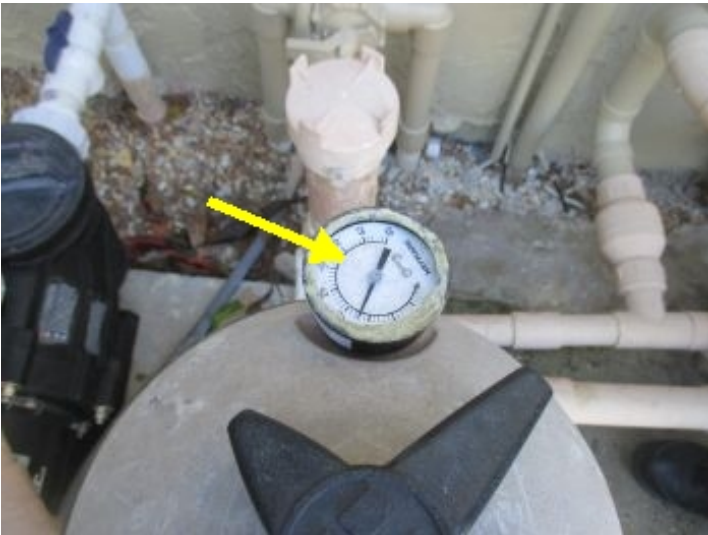
Filter pressure gauge did not appear to operate.

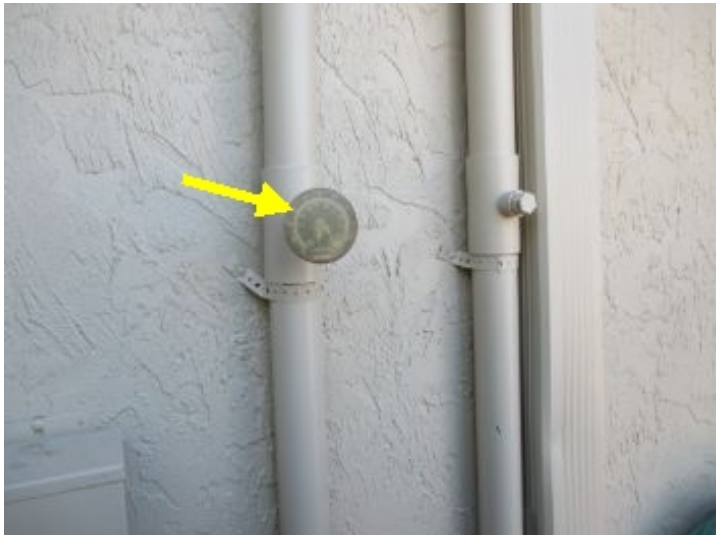
Filter pressure gauge did not appear to operate.

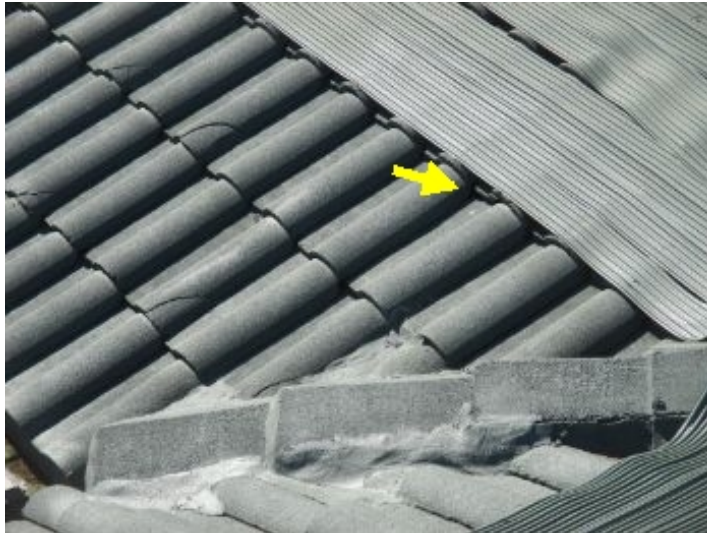
Solar piping on roof was leaking.

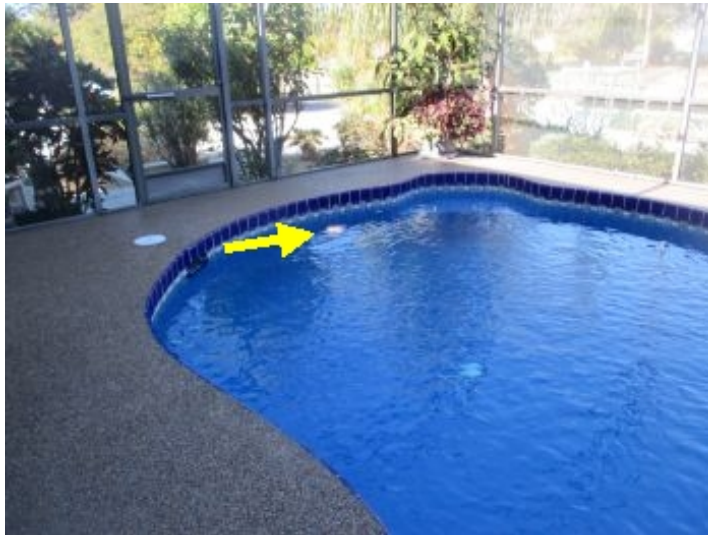
Pool light operated at the time of the inspection.

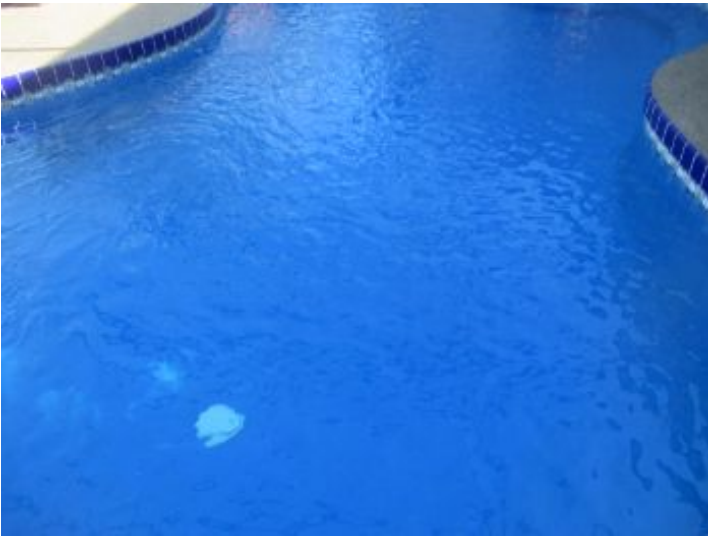
Cosmetic pool finish appeared to be in good condition.

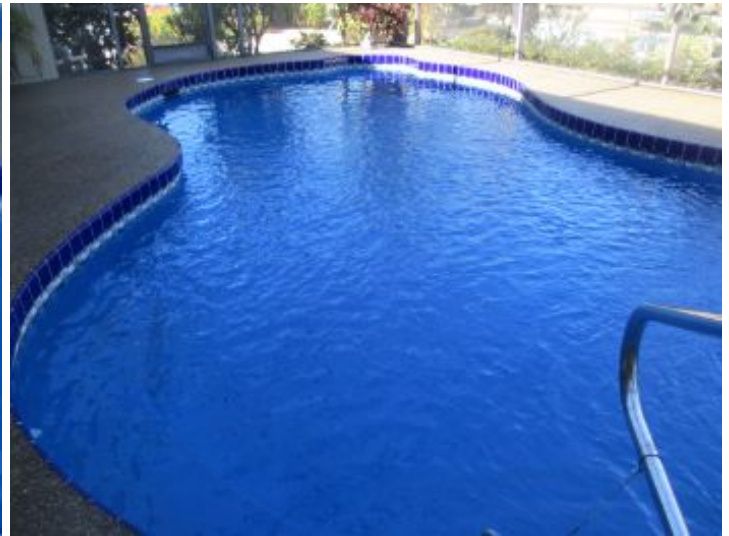
Cosmetic pool finish appeared to be in good condition.

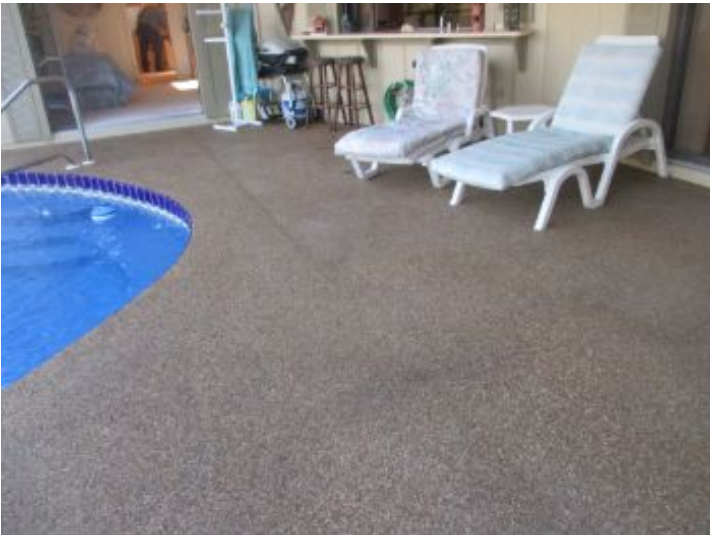
General overall condition appear satisfactory at the time of inspection.

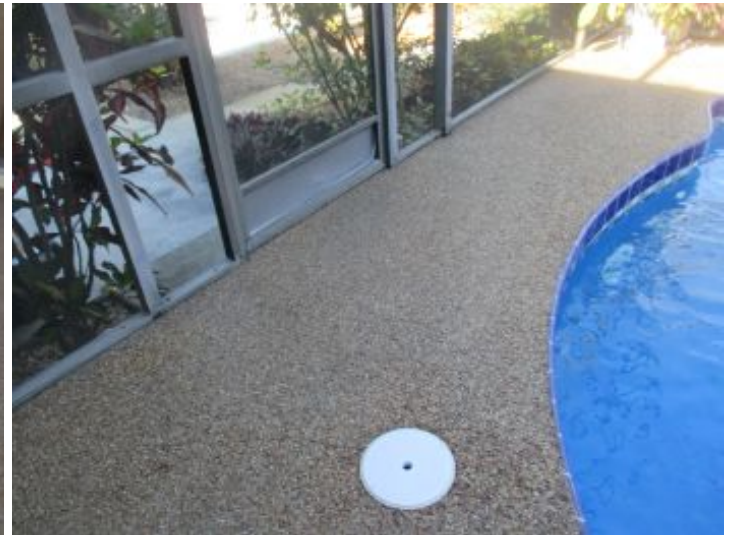
General overall condition appear satisfactory at the time of inspection.

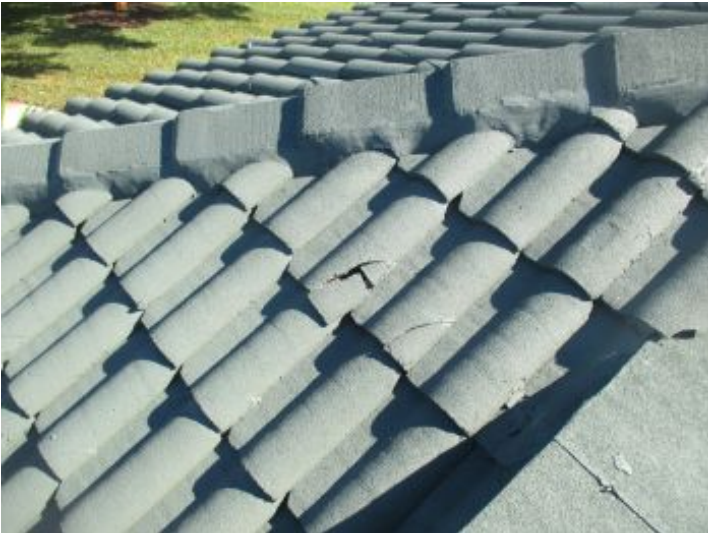
Many cracked and broken tiles on the roof. Recommend evaluation by a licensed roofing contractor.

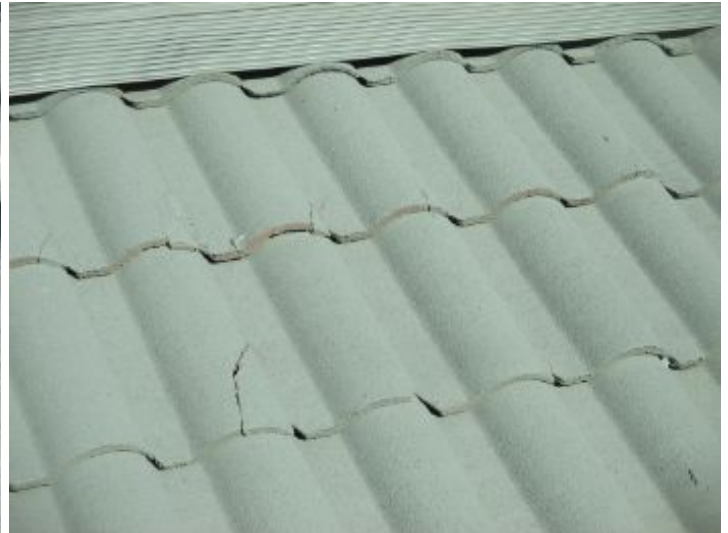
Many cracked and broken tiles on the roof. Recommend evaluation by a licensed roofing contractor.

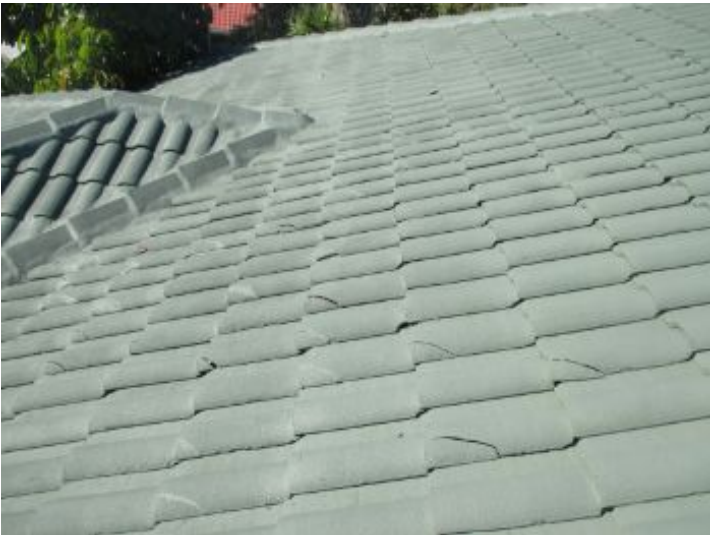
Many cracked and broken tiles on the roof. Recommend evaluation by a licensed roofing contractor.

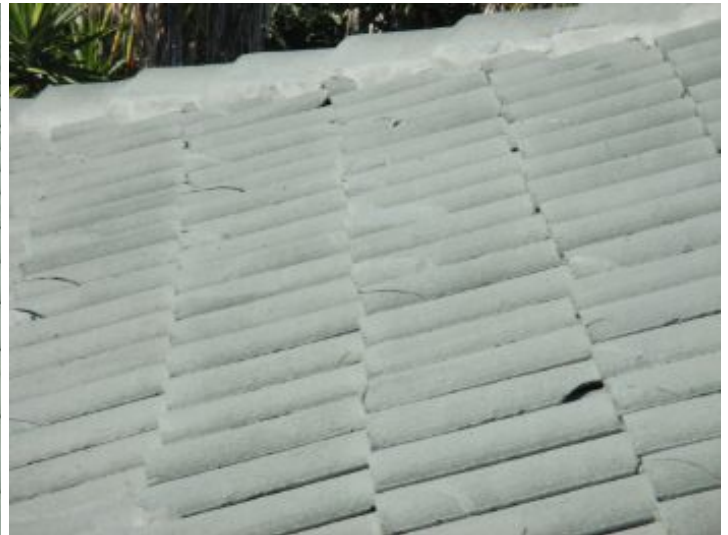
Many cracked and broken tiles on the roof. Recommend evaluation by a licensed roofing contractor.

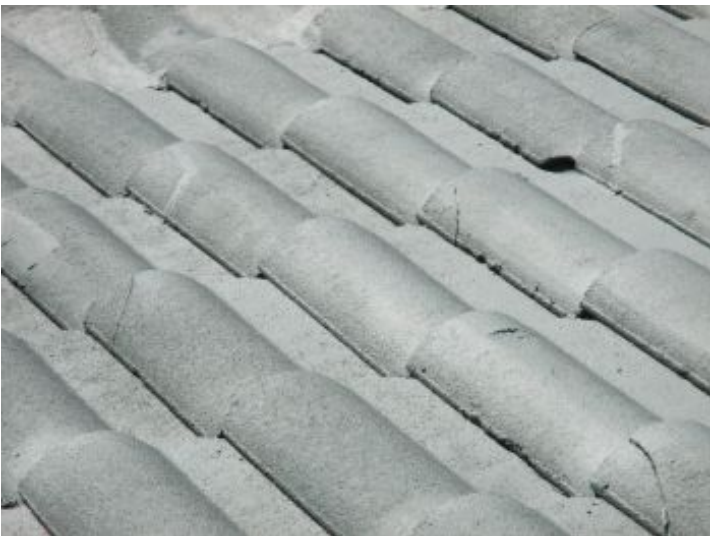
Many cracked and broken tiles on the roof. Recommend evaluation by a licensed roofing contractor.

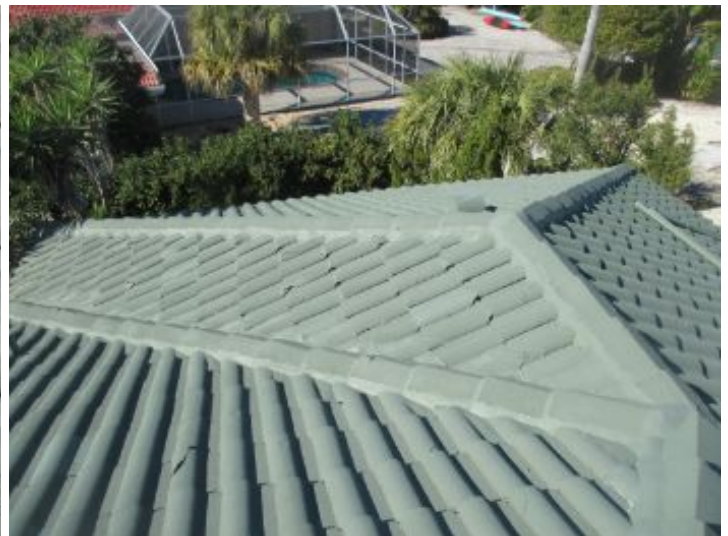
Many cracked and broken tiles on the roof. Recommend evaluation by a licensed roofing contractor.

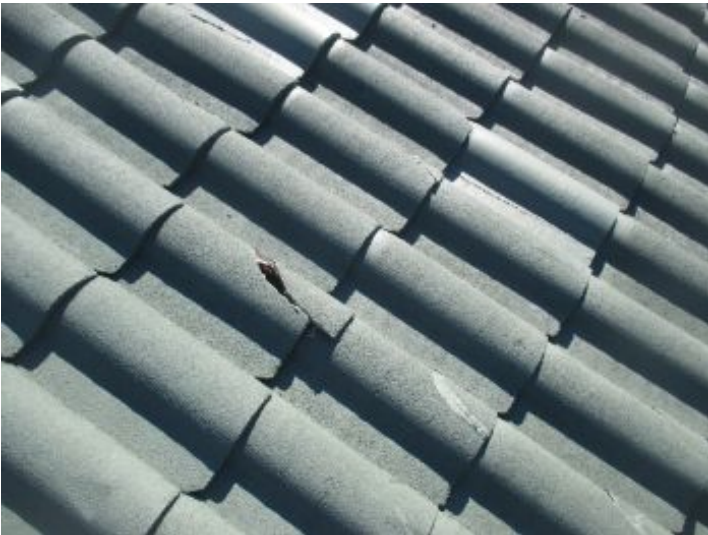
Many cracked and broken tiles on the roof. Recommend evaluation by a licensed roofing contractor.

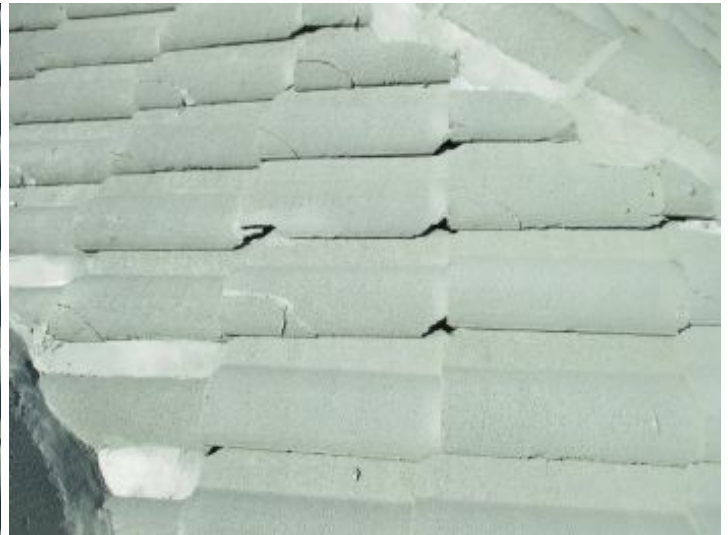
Many cracked and broken tiles on the roof. Recommend evaluation by a licensed roofing contractor.

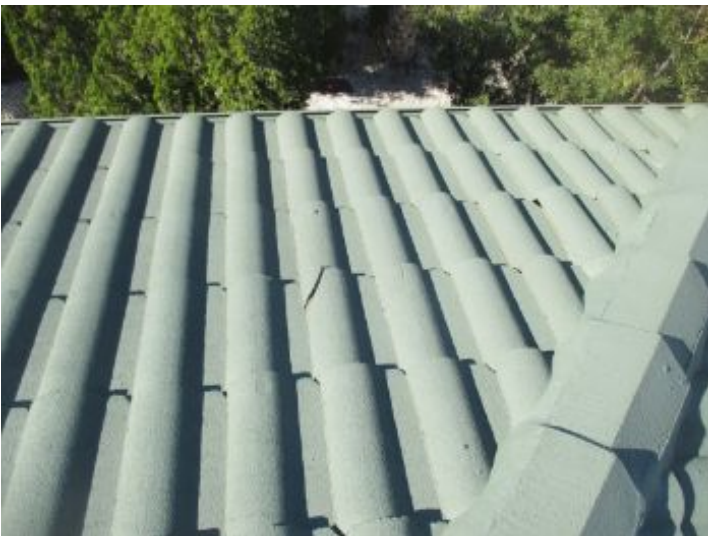
Many cracked and broken tiles on the roof. Recommend evaluation by a licensed roofing contractor.

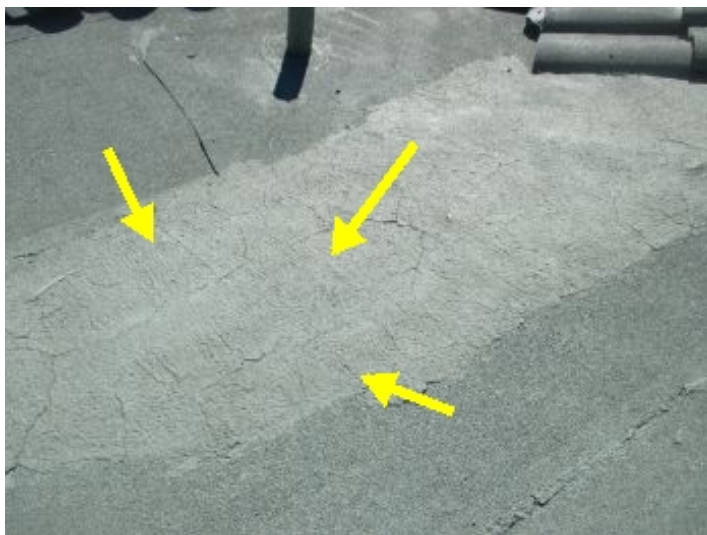
Previous repair observed. Recommend monitoring and seal or repair as needed.

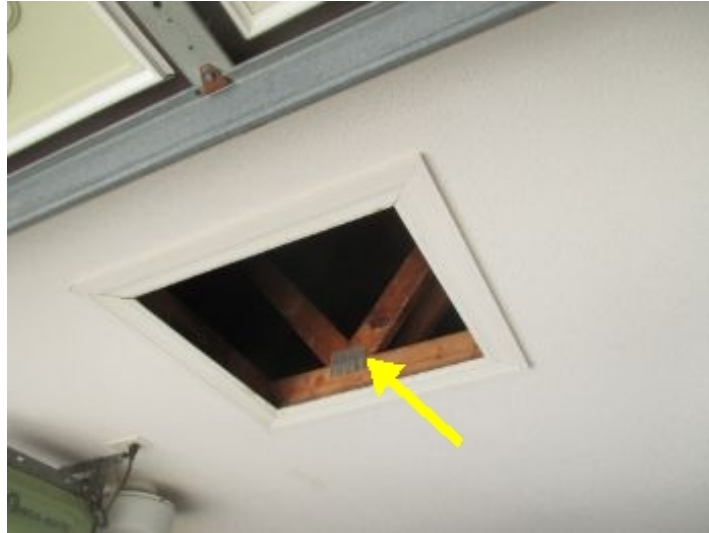
Scuttle cover in garage was missing.

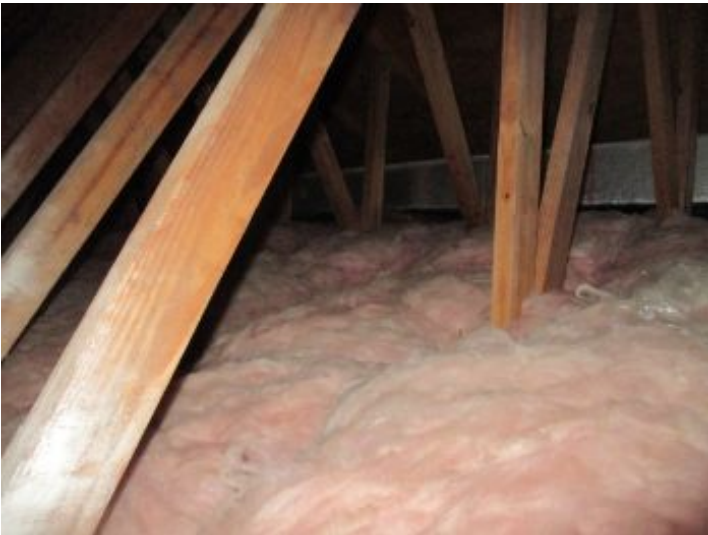
General overall condition appear satisfactory at the time of inspection.

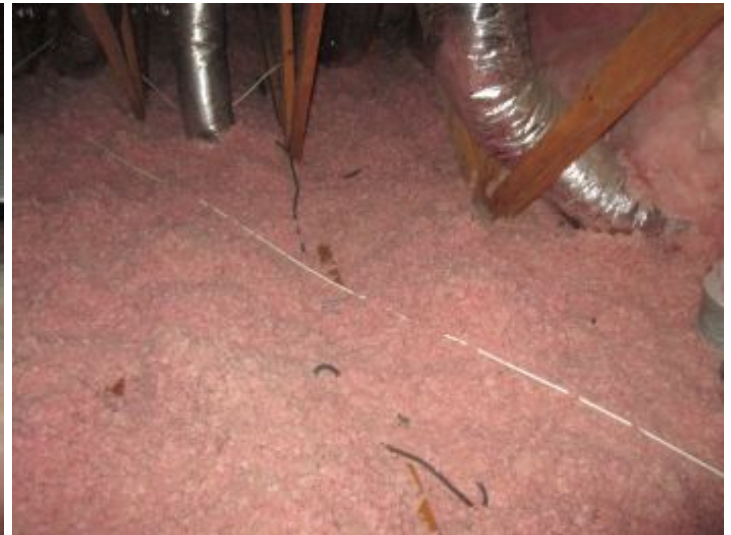
General overall condition appear satisfactory at the time of inspection.

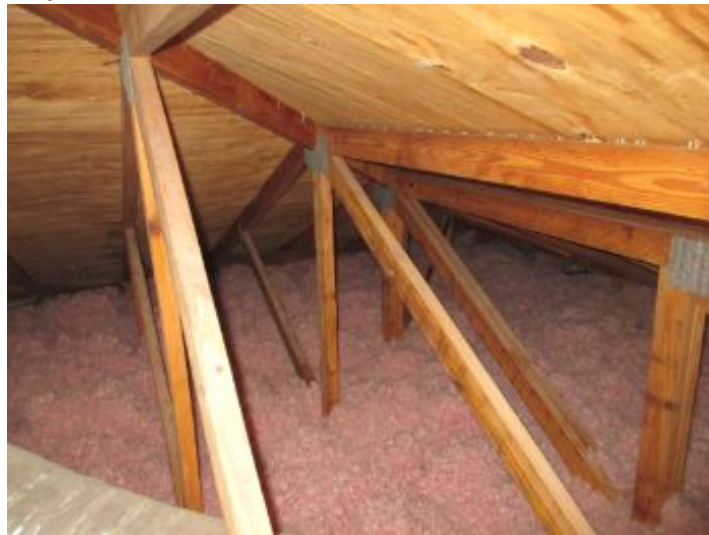
General overall condition appear satisfactory at the time of inspection.

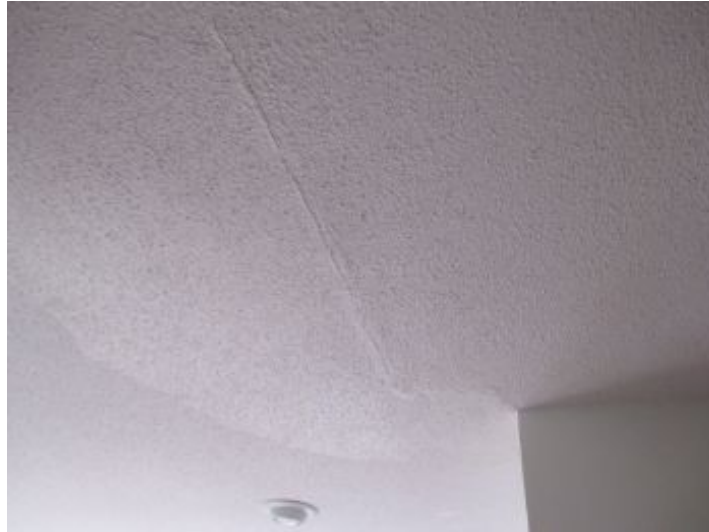
Some cosmetic, common small cracks and typical flaws in drywall finish noted.

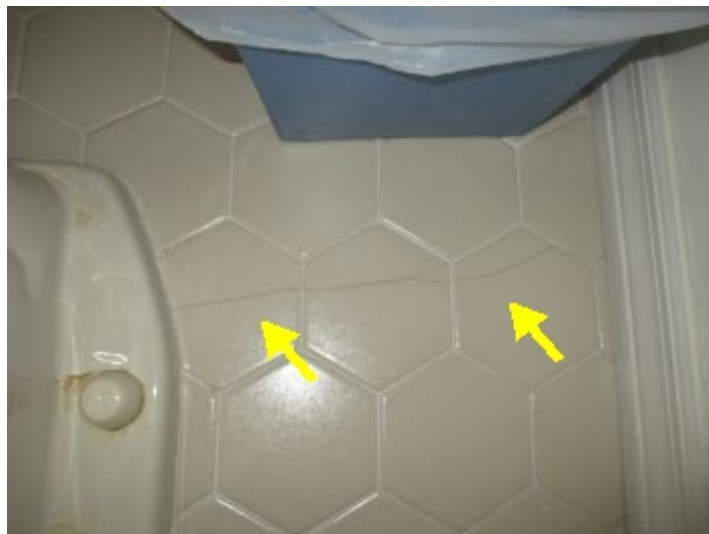
Cracked / damaged tile(s)

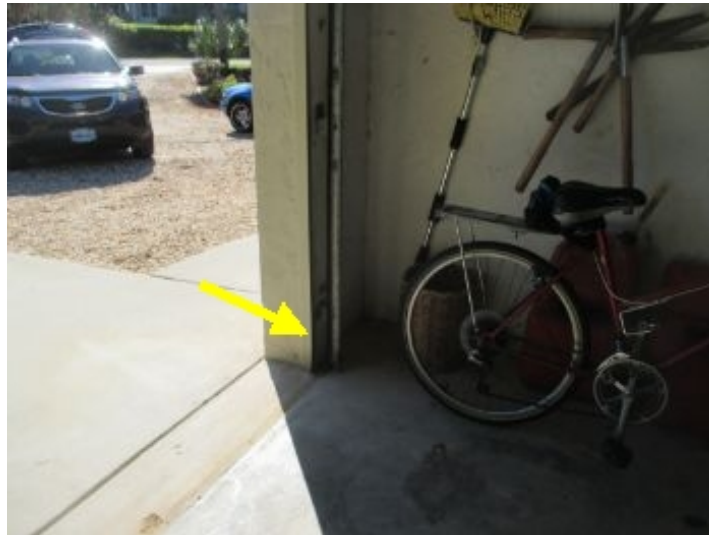
Recommend installing a mechanism that automatically reverses the door if it comes in contact with an object. This may not have been required when this home was built.

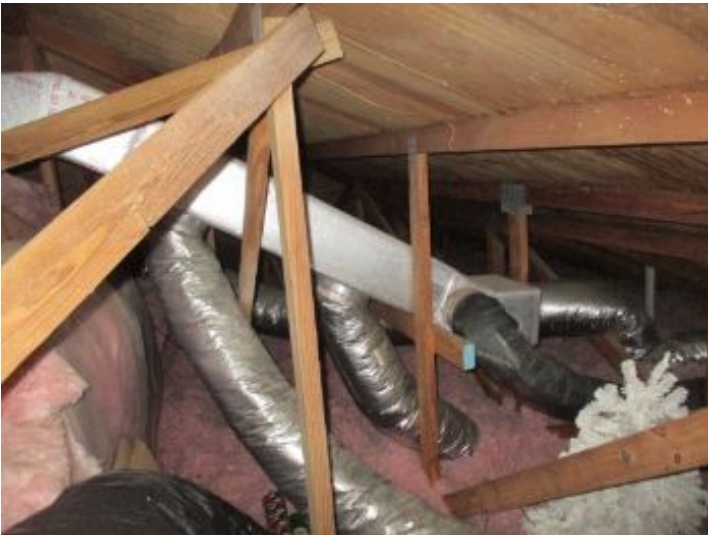
Visible areas appeared functional and in satisfactory condition at the time of inspection.

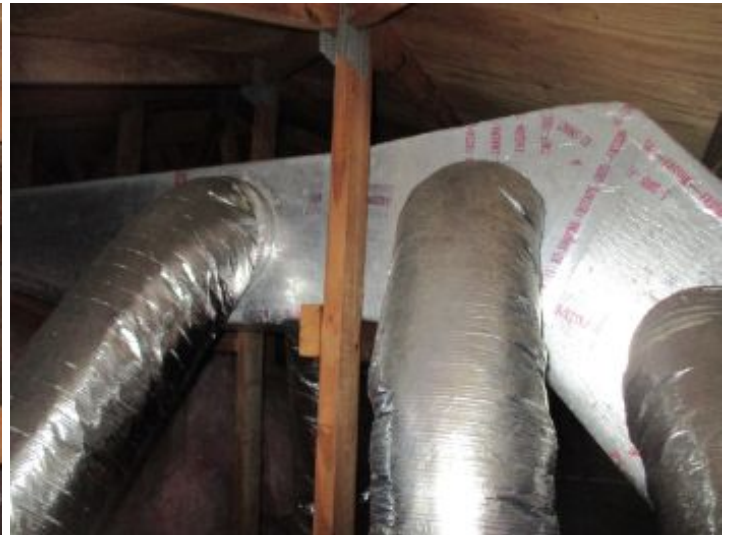
Visible areas appeared functional and in satisfactory condition at the time of inspection.

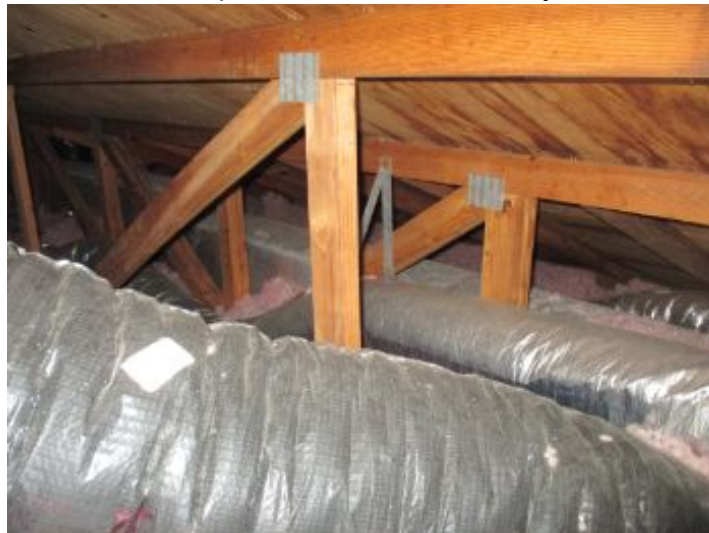
Visible areas appeared functional and in satisfactory condition at the time of inspection.

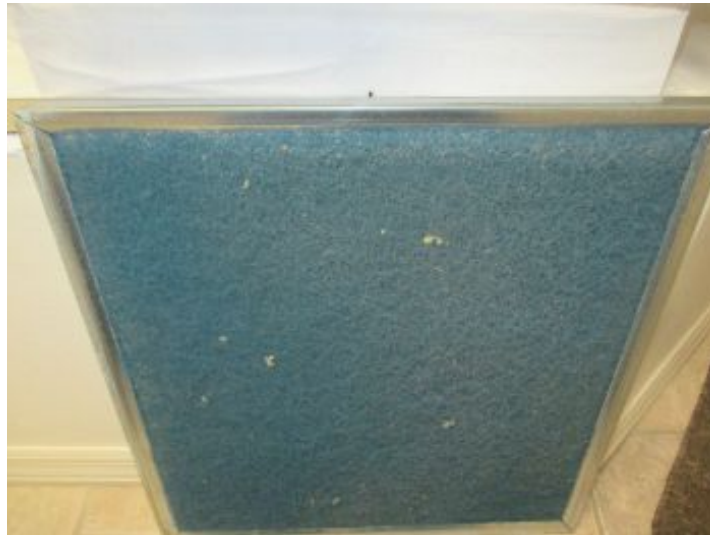
Appeared functional and in satisfactory condition at the time of inspection.

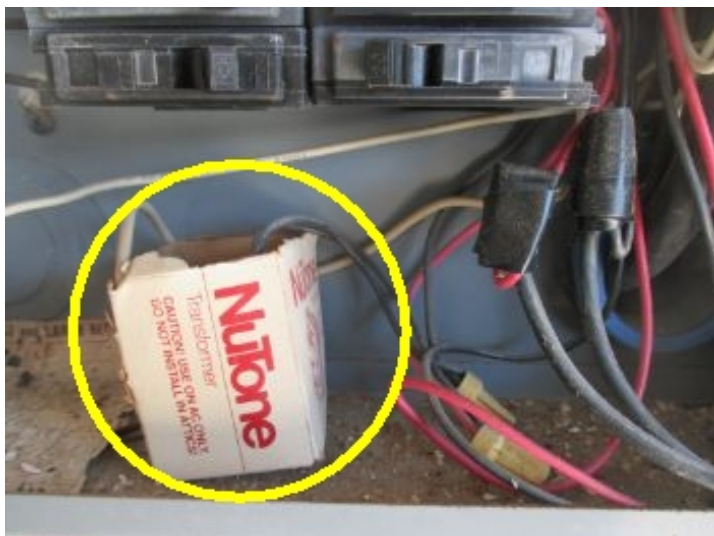
Door bell transformer located in the main electric panel, recommend relocating.

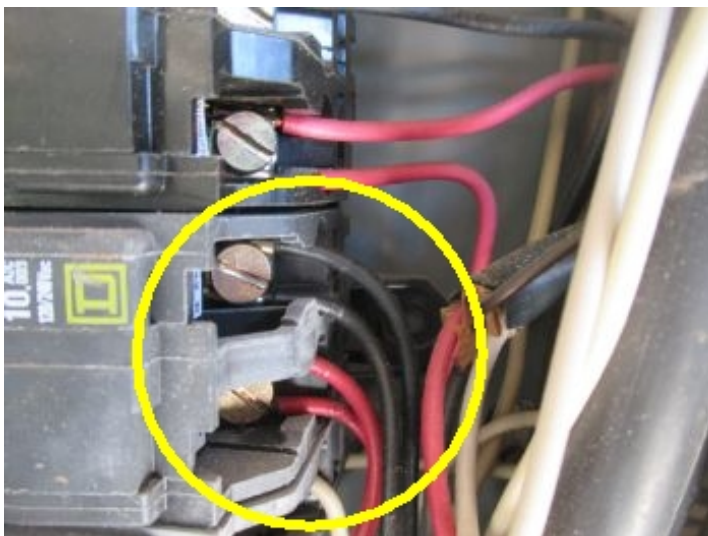
Sub panel circuit double tapped on 20 amp circuit breaker.

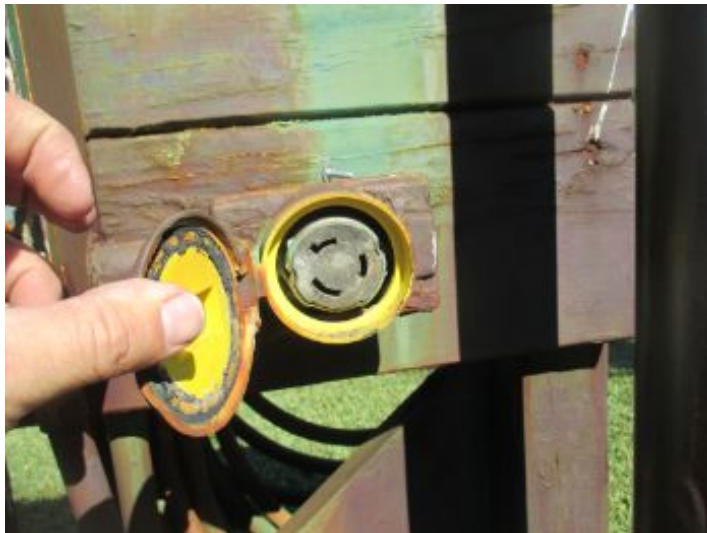
220 VAC receptacle adjacent to sub panel not connected in panel.

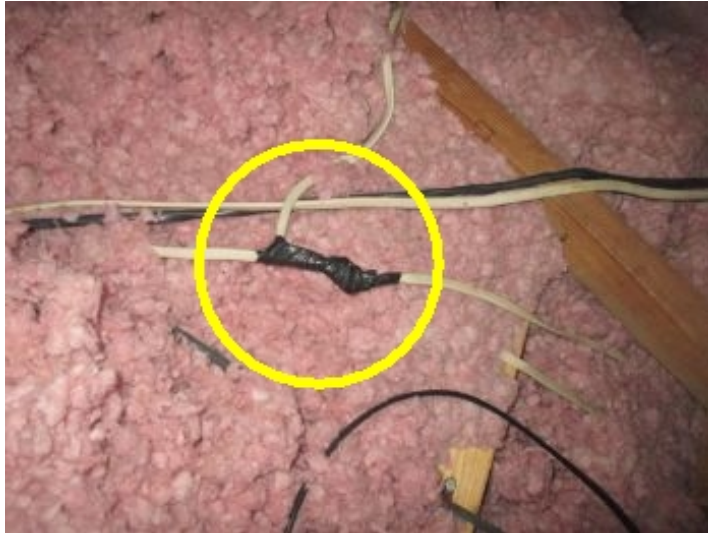
Improper wire splices, recommend installing junction box and proper connections.

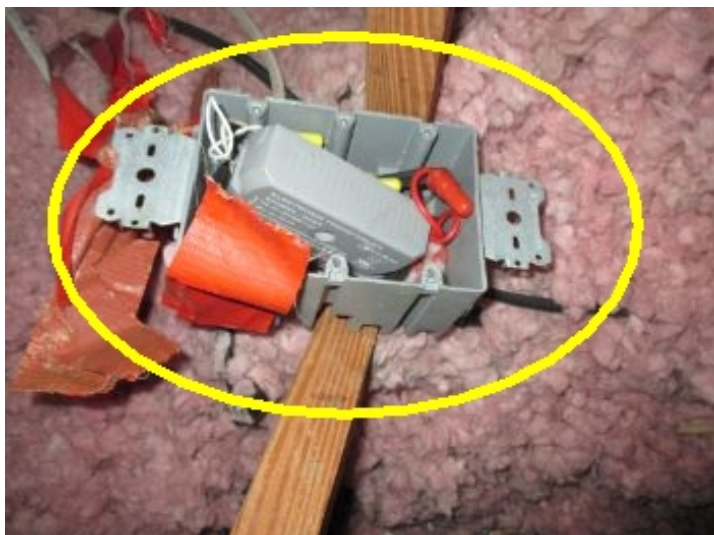
Low voltage transformer for kitchen under cabinet lights located in attic. It should be covered / secured.

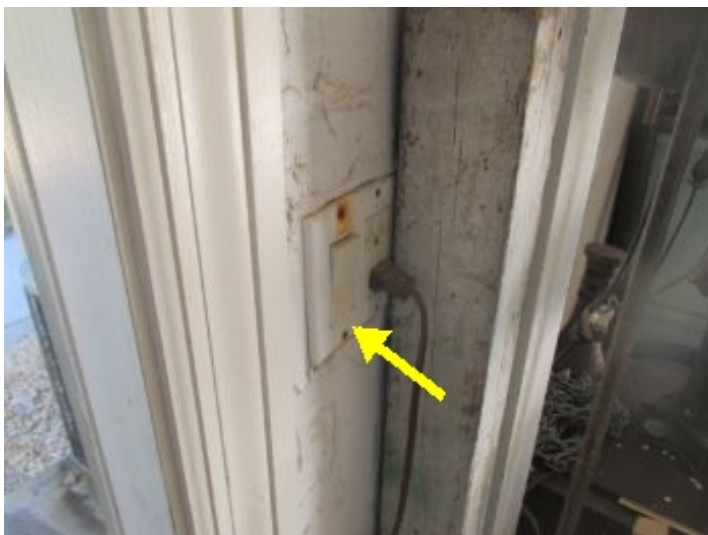
Switch did not operate properly / worn.

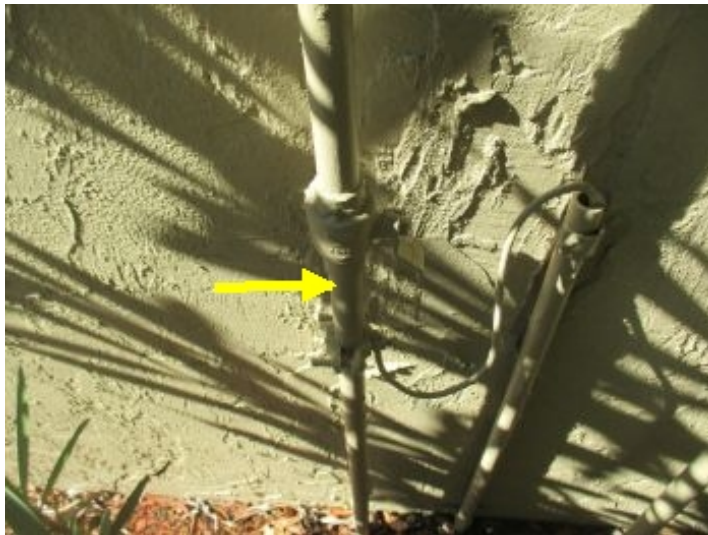
Main water shut off located on the right side of the home.

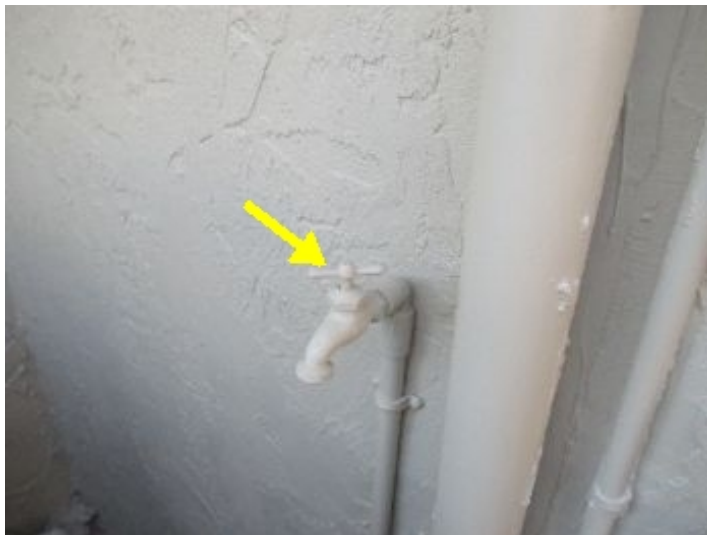
Hose faucet did not operate at the time of the inspection.

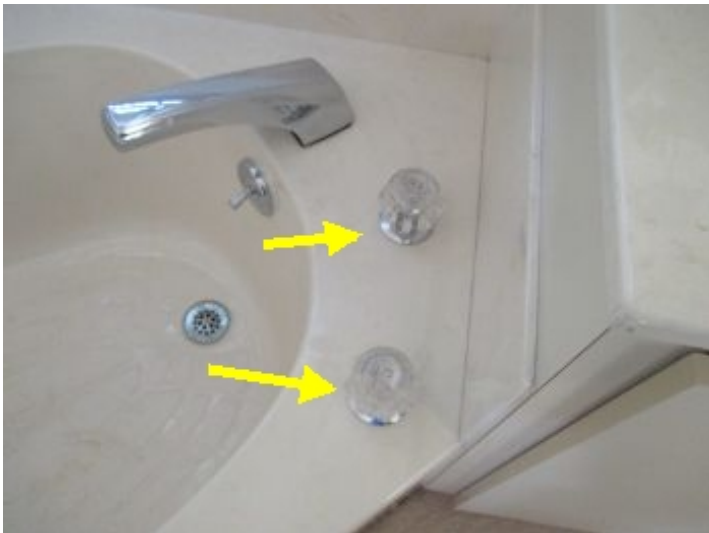
Tub faucet did not operate properly. Water is turned off at shutoffs located in the vanity access panel.

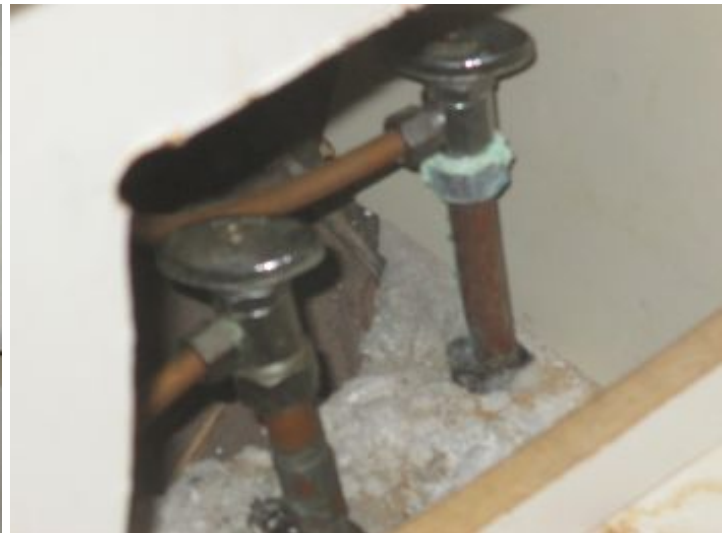
Tub faucet did not operate properly. Water is turned off at shutoffs located in the vanity access panel.

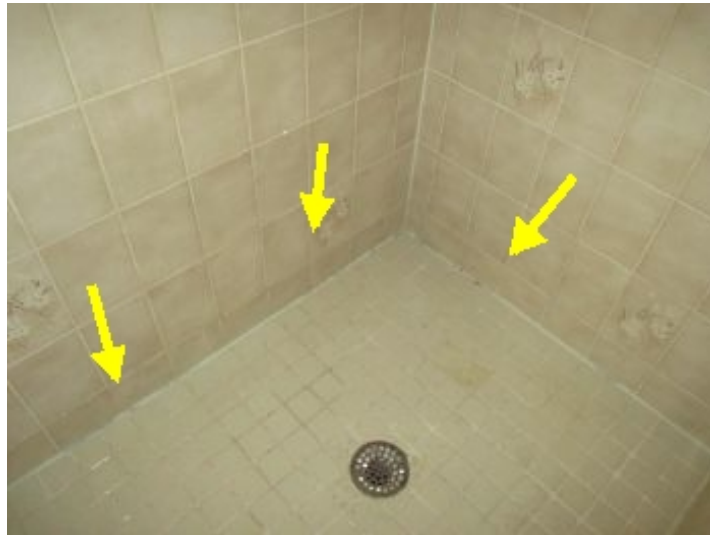
Caulk and / grout tiles as needed.

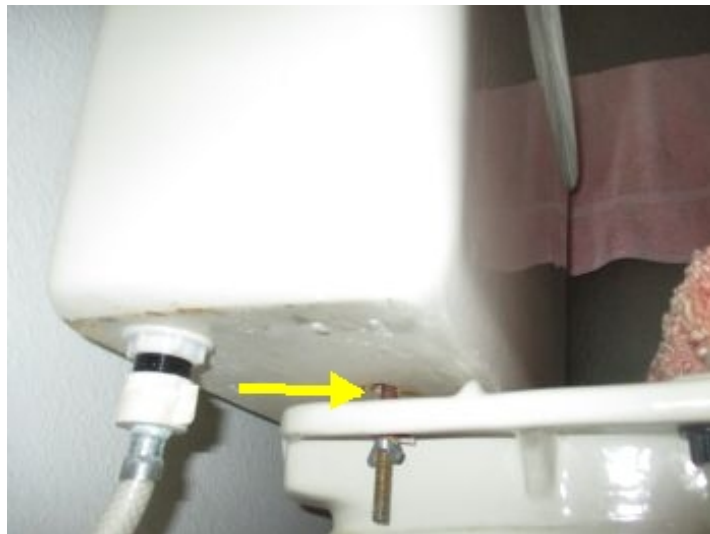
Toilet leaked between tank and toilet. This is likely due to a deteriorated gasket ring between the toilet and tank.

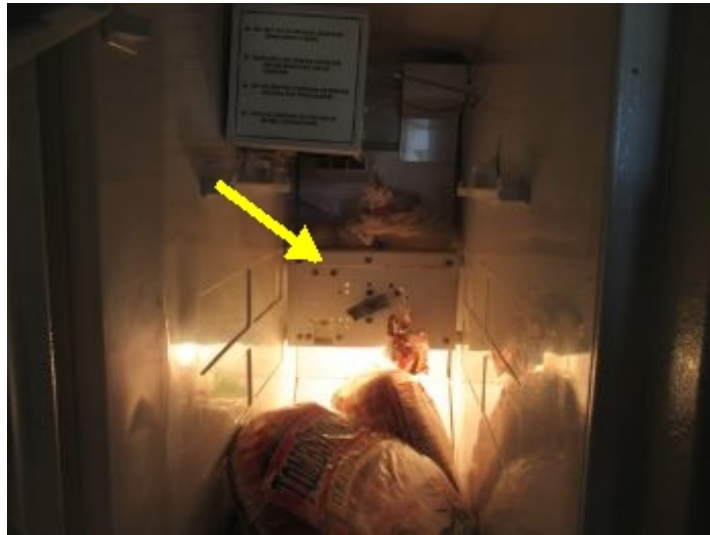
Ice maker did not operate / leaked.
